Creating materials banks  
from digital urban mining

# **D10.3: Strategic planning and data collection report 3**

As part of Work Area 6: Demonstrators in Existing Built Works, Task 10.3 in Work Package 10 has focused on establishing a baseline assessment for the Svalbard pilot site in Longyearbyen. The objective has been to develop a strategic plan for pilot implementation and testing, supported by the identification, analysis, and digitalization of the pilot building. This preparatory work provides the technical basis for subsequent pilot activities in Work Package 11 where analysis of the harvested data will be conducted.

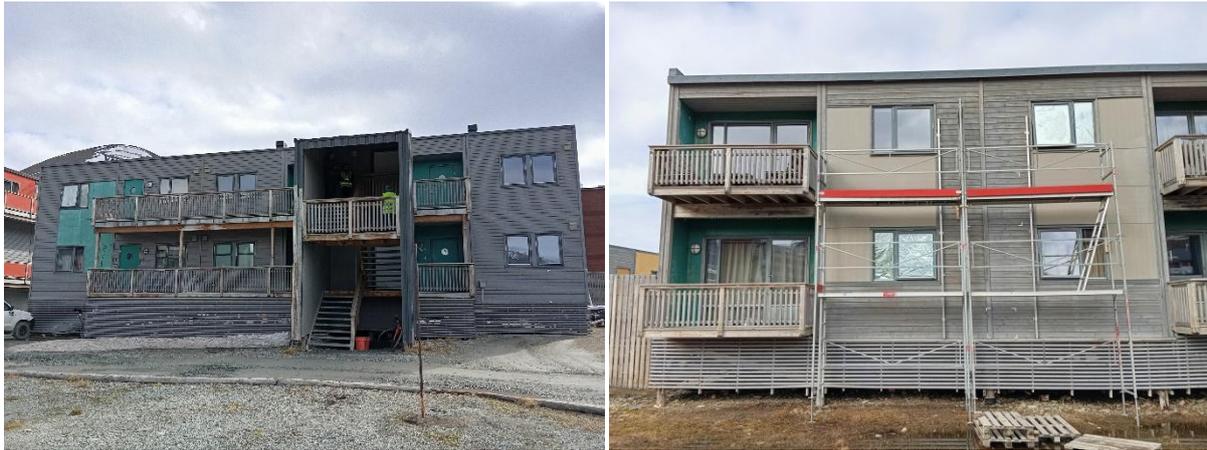
**Figure 1. Pilot building in Svalbard (left: front side; right: rear side)**

At the outset of SUM4Re, building module relocation was intended: the building modules were foreseen to be disassembled and reassembled at a different site in Svalbard, demonstrating direct reuse of whole modules. Although this plan was later withdrawn due to economic and other practical reasons, the concept remains highly relevant since many similar buildings may face the same destiny as ground conditions continue to evolve.

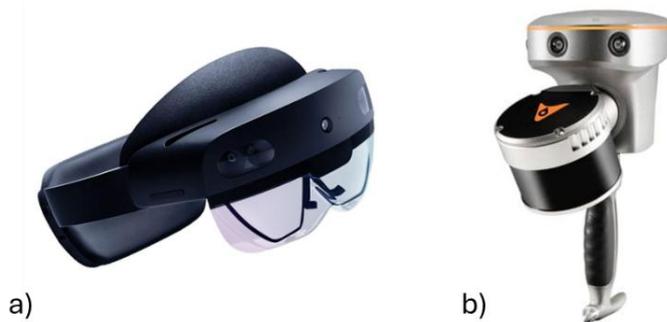
The device used for data collection was the Microsoft HoloLens 2, where specific software was developed and implemented to capture the 3D environment, position virtual markers, and take referenced RGB photos. However, Microsoft does not provide technical specifications for this device, beyond indicating that it has a range of 5 m and a battery life of 2 hours. It was necessary to perform a performance analysis to determine the limits of the AR glasses in different light and atmospheric conditions (more information in Deliverable D2.1). The HoloLens 2 integrates various sensors necessary for data collection, such as a depth sensor (Time of Flight (ToF) LiDAR), an RGB camera, four cameras for hand tracking, and an inertial measurement unit (IMU). Figure 5a shows an image of the HoloLens 2.

**Figure 5. Microsoft HoloLens 2 (a) and CHCNAV RS10 (b)**

In addition, a Handheld Mobile Laser Scanner (HMLS) CHCNAV RS10 was used to obtain reference data in the evaluation of the quality of the point clouds generated by the HoloLens 2. The technical specifications of this device are shown in Table 3. An image of the CHCNAV RS10 is shown in Figure 5b.

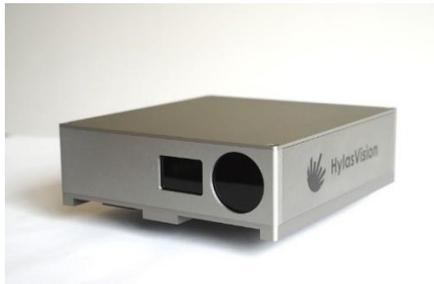
<b>Image or drawing of the scanner:</b>

<b>Size:</b>	245mm x 229mm x 75mm
<b>Weight:</b>	3.2 kg (+2.5 kg of tripod)
<b>Placement method:</b>	Mounted on a tripod
<b>Resistance to weather conditions:</b>	IP63 (dust-tight, protected against sprays of water)
<b>Other properties to take into account:</b>	<p>No batteries or on-device control unit in current prototype. External electrical power required for AHS device as well as for laptop for control.</p> <p>Operates with class IV laser. Laser safety goggles should be provided to personnel/others in the area. If the area to be scanned is normally used by people without training in laser safety (e.g. a school, a busy street pavement), it should be evacuated for the measurements.</p>

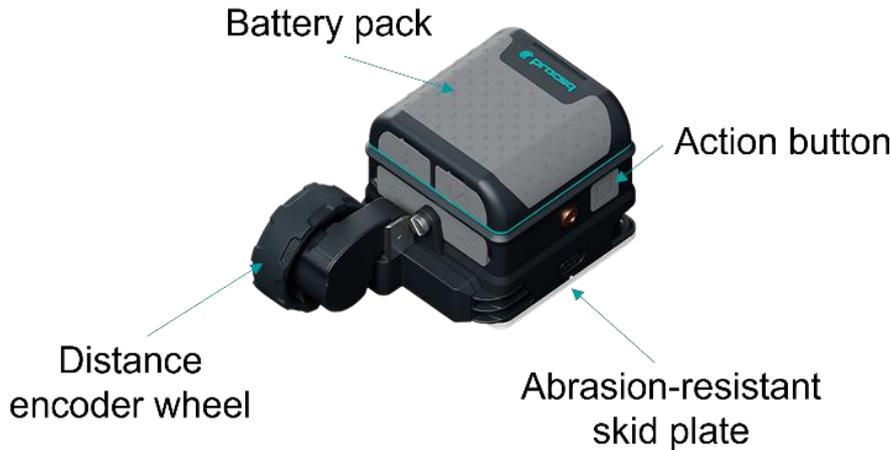
This particular antenna has been designed to operate in direct contact with the ground or a material surface in order to maximize the penetration depth. Its main application is reinforced concrete scanning to pinpoint structure elements such as reinforcing bars, conduits, post-tension cables and for concrete assessment, however it is also being used for the inspection of wooden utility poles. This transducer along with some of its features annotated is illustrated in Figure 6.

**Figure 6. The Proceq GP8800 transducer along with some of its features annotated**

Table 5 summarizes some of the key technical specifications of the GP8800 probe.

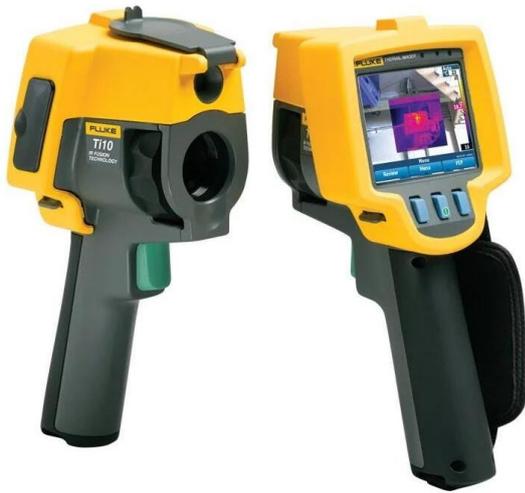
Fluke Ti10 Thermal Imager (Figure 7, Table 6) was used to collect information about the surface temperature. It is widely used industrial-grade thermal imaging camera with 160 x 120 focal plane array, uncooled microbolometer and range from 20°C to +250°C. It is designed for predictive maintenance, troubleshooting, and verification in harsh environments. Its main drawback is fixed emissivity setting to 0.95, which is acceptable for the common material surfaces excepting shiny metals.

Figure 7. Fluke Ti10 Thermal Imager (picture credits: Fluke Corporation)

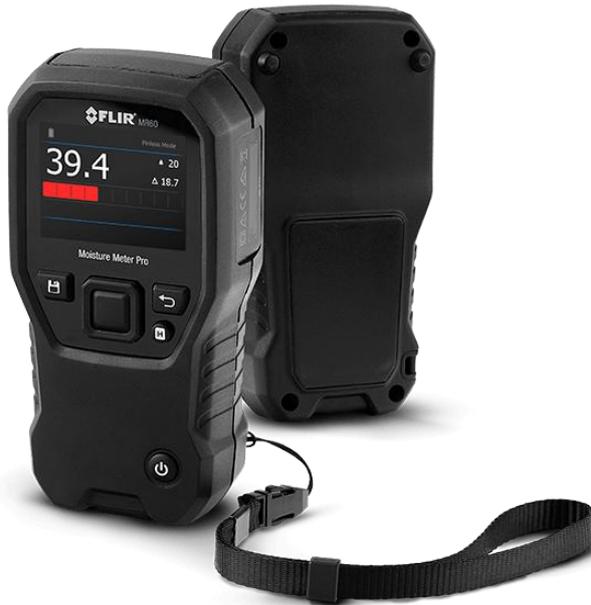
FLIR MR60 Moisture Meter Pro (Figure 8, Table 7) was used to collect the information about the material moisture. It is a dual-function, handheld instrument designed for quantitative and qualitative moisture analysis in a wide range of materials. It integrates both pin-based (resistive) and pinless (dielectric) measurement technologies, allowing for destructive and non-destructive testing, respectively.

**Figure 8. FLIR MR60 Moisture Meter Pro (picture credits: Teledyne FLIR)**

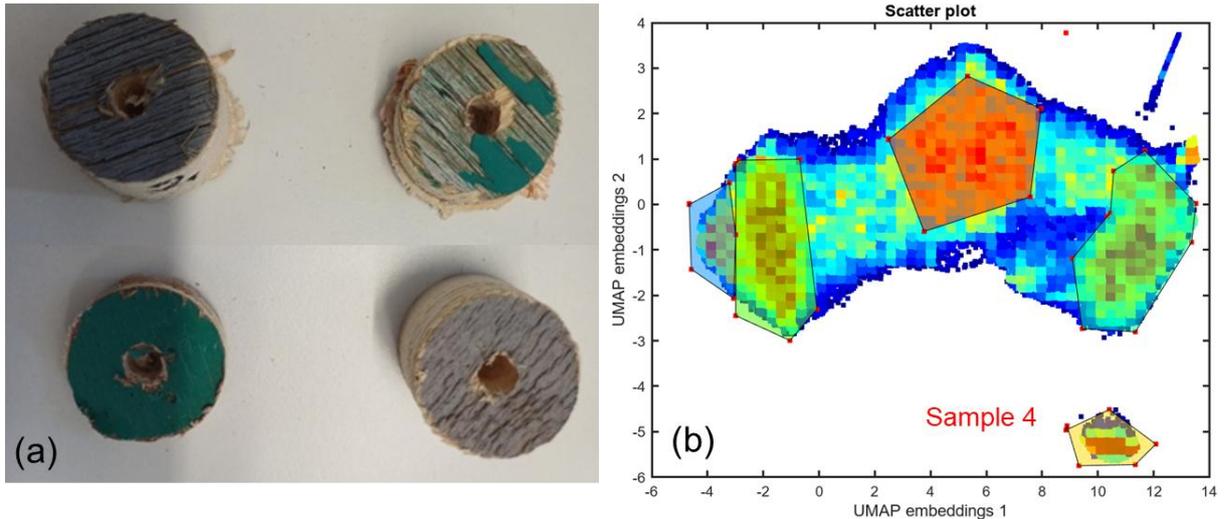
Figure 9 shows photos of the samples, as well as preliminary cluster analysis based on Uniform manifold approximation and projection (UMAP). More detailed explanations regarding the calibration data acquisition and analysis will be given in deliverables D2.2 and D3.2.

Figure 9. Wood samples analysed in the VTT laboratory with AHS and conventional HIS prior to the pilot test. (a) Sample photos; (b) UMAP analysis scatter plot.

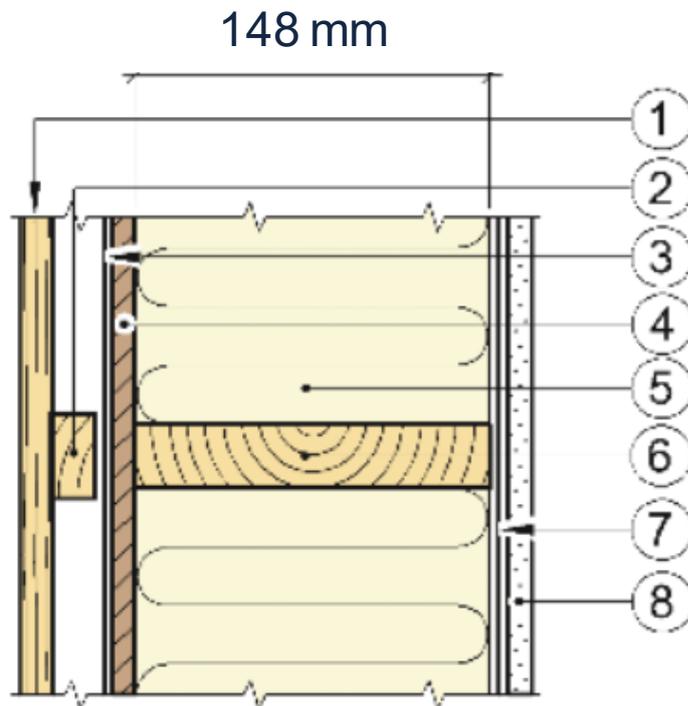
Figure 10. Horizontal section view of pilot outer wall with material composition <sup>14</sup>

<sup>14</sup> 1) 19x148 mm horizontal double-beveled cladding with two layer of system coat; 2) 23x48 mm battens/ventilation c/c 600 mm; 3) Wind barrier; 4) 12 mm windproof asphalt panels; 5a) 150 mm glass wool insulation; 5b) 150 mm rock wool insulation; 5c) 150 mm wood fibre insulation; 6) 36x148 mm studs C24; 7) 0.15 mm plastic film/vapor barrier; 8) 9 or 11 mm medium/high density fibre board; 9a) 36x148 mm C24; 9b) 36x148 mm C24; 10) 12 mm plywood for transportation and mock-up borders.

A mock-up of the pilot wall shown in Figure 10 was built and scanned with GPR prior to the testing in Svalbard in order to assess what information we can extract using GPR in this type of structures. The results from the mock-up will also help with the interpretation of the data from Svalbard. The sample has dimensions of 1200 × 800 × 211 mm and consists of different layers as seen in Figure 11.

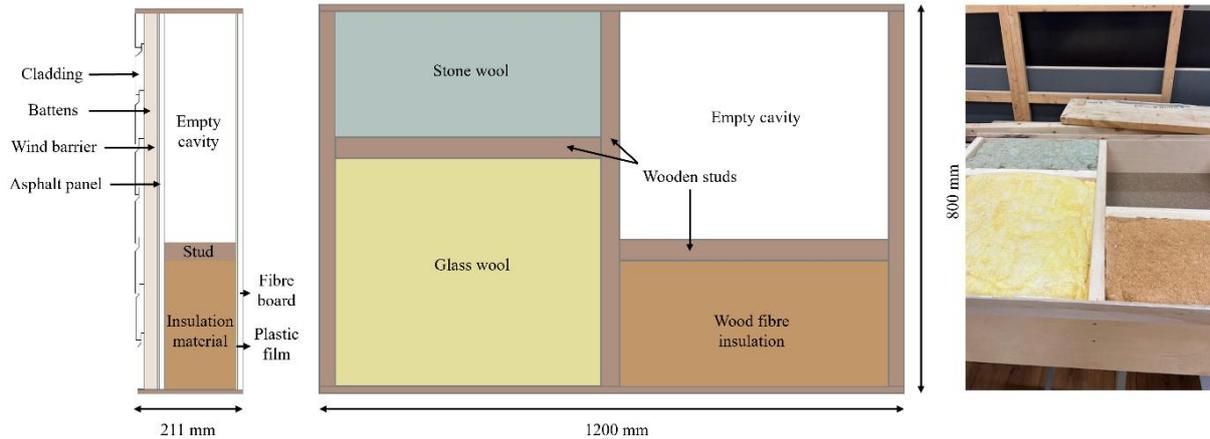
**Figure 11. Structure of the mock-up wall. Left: Side view which shows the different layers, Middle: Structure of the insulated region, Right: Image of the insulated region for reference.**

The sample was scanned using the high-resolution Proceq GP8800 GPR system. At first, line scan measurements were acquired to calibrate for the bulk dielectric/velocity through the medium utilising the known thickness of the specimen. The calibrated dielectric/velocity values were needed as these are used for calculating the depth. As electromagnetic waves travel faster through air, a dielectric of 1.3 was estimated for the region that includes the empty cavity (as most of the wall has air), and 2.0 for the regions where insulation materials exist.

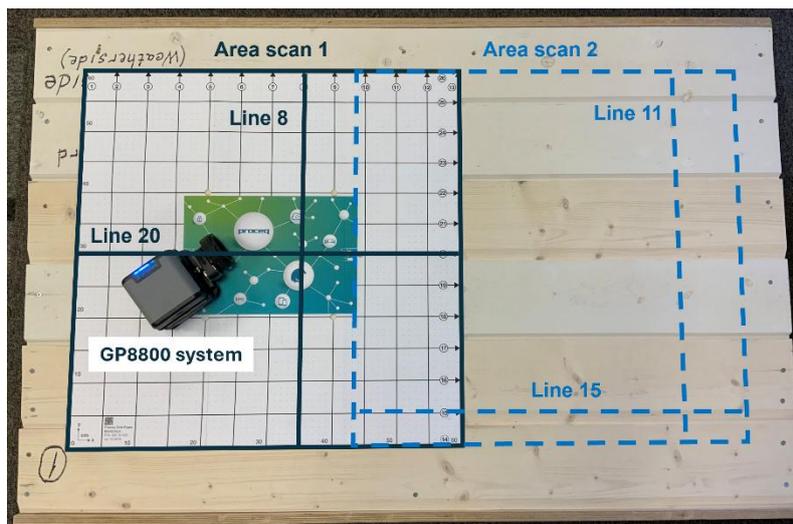
For the data acquisition on the mock-up, two area scans of 60 x 60 cm were conducted on each side (external cladding and internal side) to ensure the full mock-up is scanned, leading to a total of four area scans. In the area scans, measurements were collected with a spacing of 5 cm, both in the x and in the y direction. Therefore, in total 26 measurement lines were collected for each area scan. To mark the area and the lines, a marked grid paper was used. The area scan locations (marked with blue shade color) along with the GP8800 GPR system and the grid paper used, can be seen in Figure 12. The same locations were scanned also from the internal side. The figure also highlights with the measurements selected and presented here. The solid lines represent measurements presented from the external side and the dashed lines measurements from the internal side.

**Figure 12. The area scan locations on the mock-up wall along with the GP8800 system. The solid lines represent scans from the external side, whereas the dashed lines, scans conducted from the internal side.**

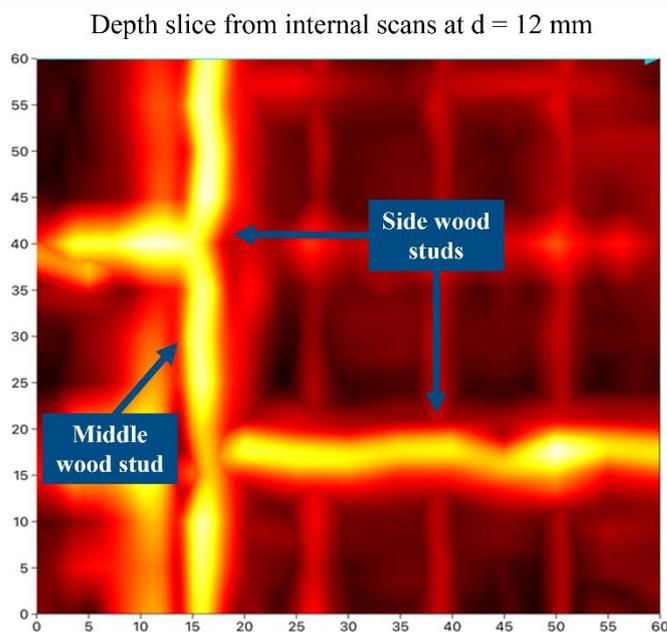
The results are presented either in the form of images, which represent a single line scan (radargram) or all the data have been combined to generate a volume from which depth slices are extracted. A depth slice from the internal scan at 12 mm depth was selected and shown in Figure 13 below. Here, the middle and wooden studs that split the insulated region in the four compartments can be identified with the depth observed in the GPR data matching their actual depth in the mock-up.

**Figure 13.** Depth slice at a depth of 12 mm from internal scan 2 where the wooden studs can be identified.

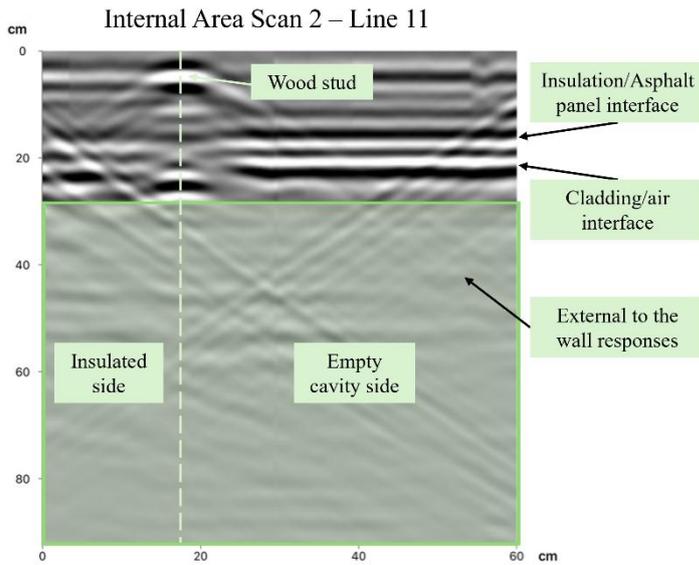
From the individual radargrams, more information can be extracted. In the internal scans, the response from the wood studs can be observed but also the insulation/asphalt panel interface and the cladding/air interface.

Signals from the edges of the mock-up can be seen in the data, called air waves, which are due to the finite size of the wall sample. These are expected to be minimized in the data of the much larger building wall in Svalbard. Looking at the responses from the two interfaces, we can see that these arrive slightly later and appear deeper in the left section of the Line 11 radargram (on the left of the light green dashed line). This is due to the insulation material where, as mentioned earlier, the waves travel slower than the right side, which has mostly air. Therefore, if this type of responses is identified, they could indicate potential change of material. These are illustrated in Figure 14. The gaps in the fibre board introduce noise but this does not affect the data significantly.

**Figure 14. Line 11 radargram from internal area scan 2 with responses detected highlighted**

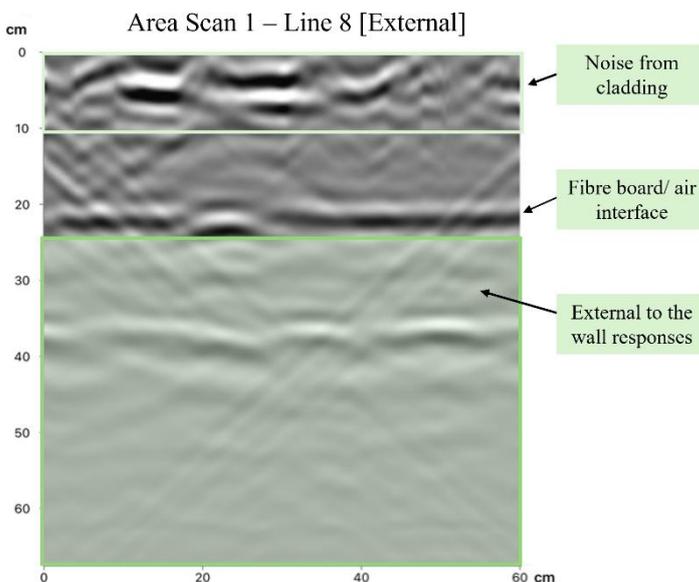
In contrast, when scanning externally, the larger gaps and the irregularities in the external cladding surface introduce significant noise (see Figure 15). In addition to this, the metallic nails on the cladding surface due to their strong signal mask the response from the wood stud. A distinction between the wooden cladding and the wooden battens layer cannot be made from the GPR data, which was expected due to their similar dielectric properties.

Although the external scans were more challenging, more information can be extracted from the external x-directed scans, where the asphalt panel/insulation and the fibre board/air (backwall) interface can be detected. The backwall response can be used to find the wall thickness in case not known, assuming the dielectric constant is known.

**Figure 15. Line 8 radargram from external area scan 1 with responses detected highlighted**

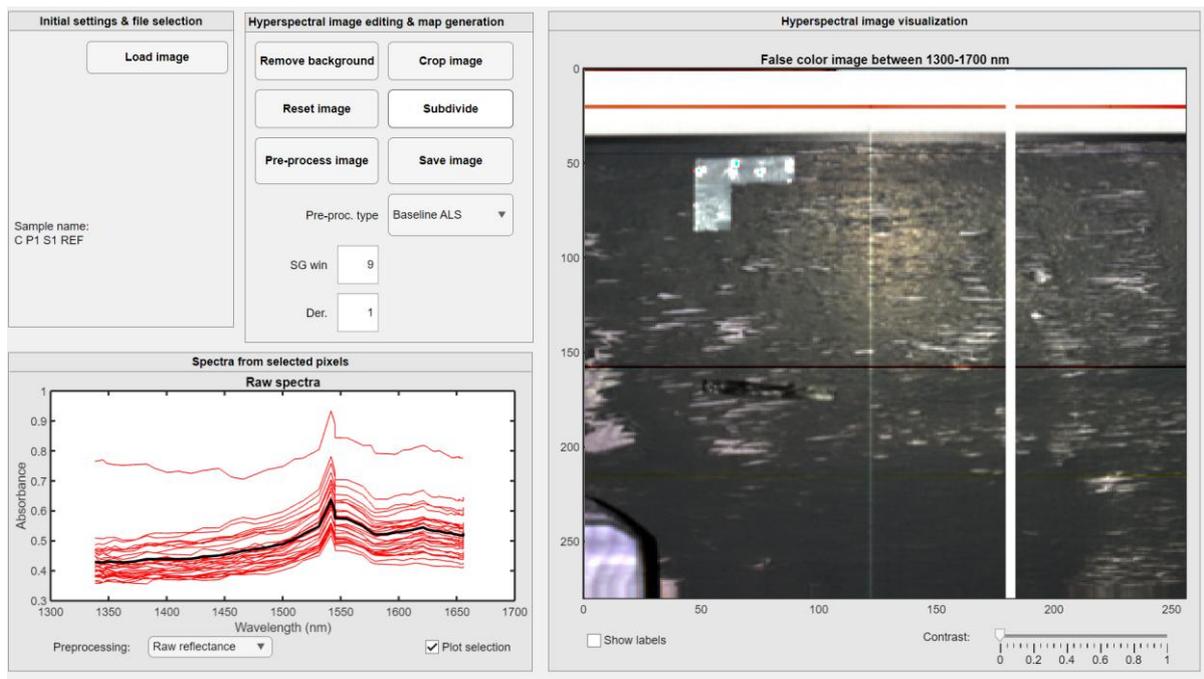
The data collected using AHS is transferred to a second laptop to avoid slowing down or interrupting the scan and checked with own Matlab application for quick evaluation of the data. This quality check is to ensure that the overall image is consistent with the scanned target, and the spectra of individual pixels do not present any anomalies. An example of raw data as viewed in the Matlab application is shown in Figure 16. The right panel shows a false color image of the scan (i.e. an RGB image created from selected NIR wavelengths that are not visible in a regular photo), and the plot on the bottom left panel shows few raw spectra of selected pixels. In this software, it is possible to quickly spot if anomalies in the spectra of pixels are present, as this will distort the corresponding area of the false colour image.

**Figure 16. Screenshot of custom Matlab application for assessing the quality of AHS data**

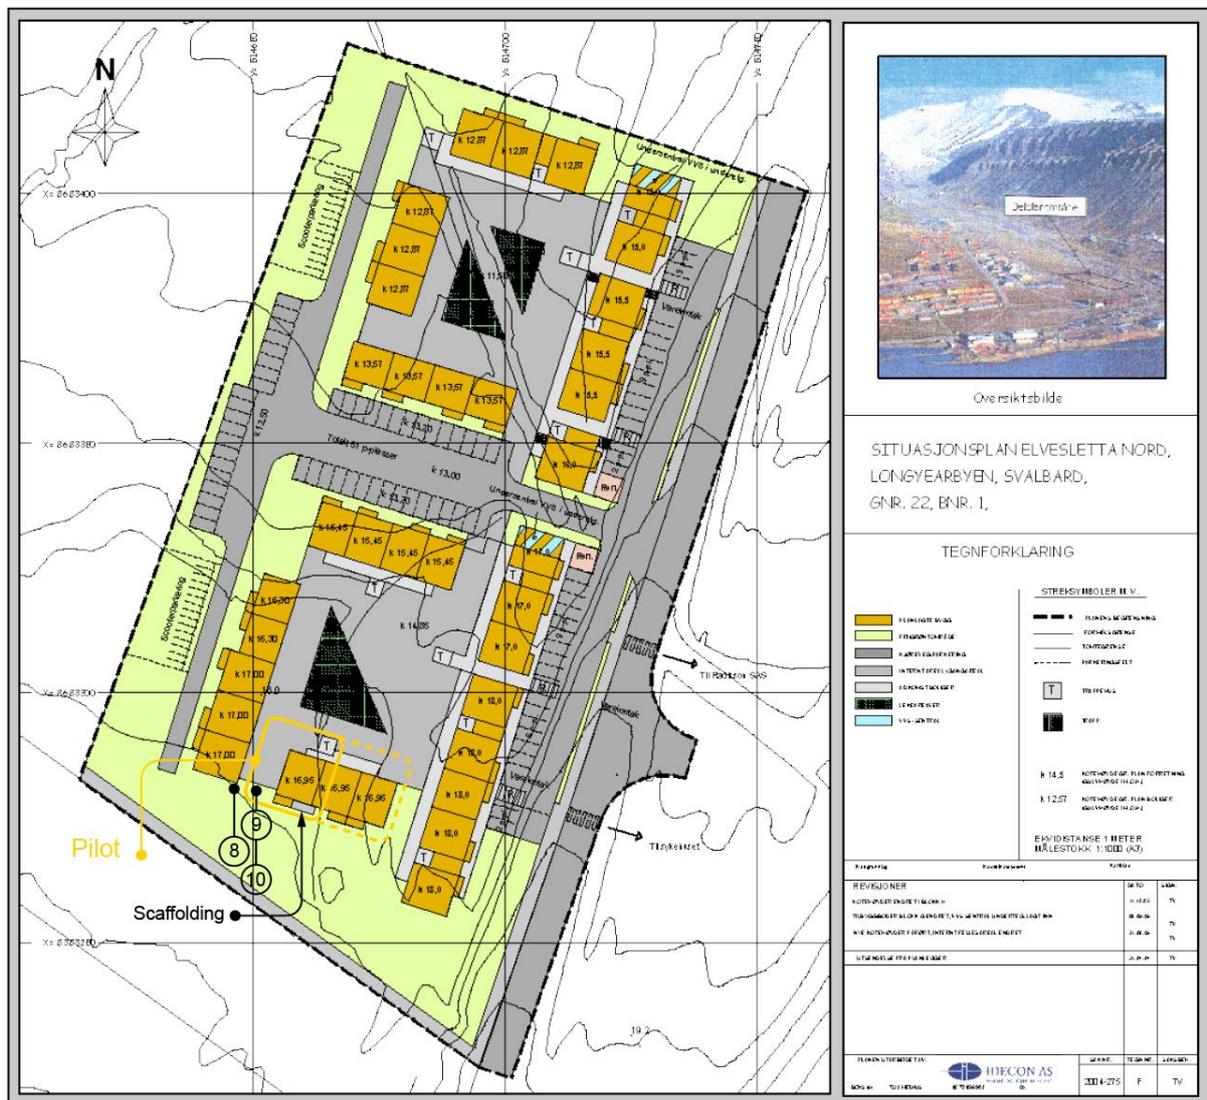
Figure 18. Situation drawing with selected scanning positions and the Nordic pilot in red border

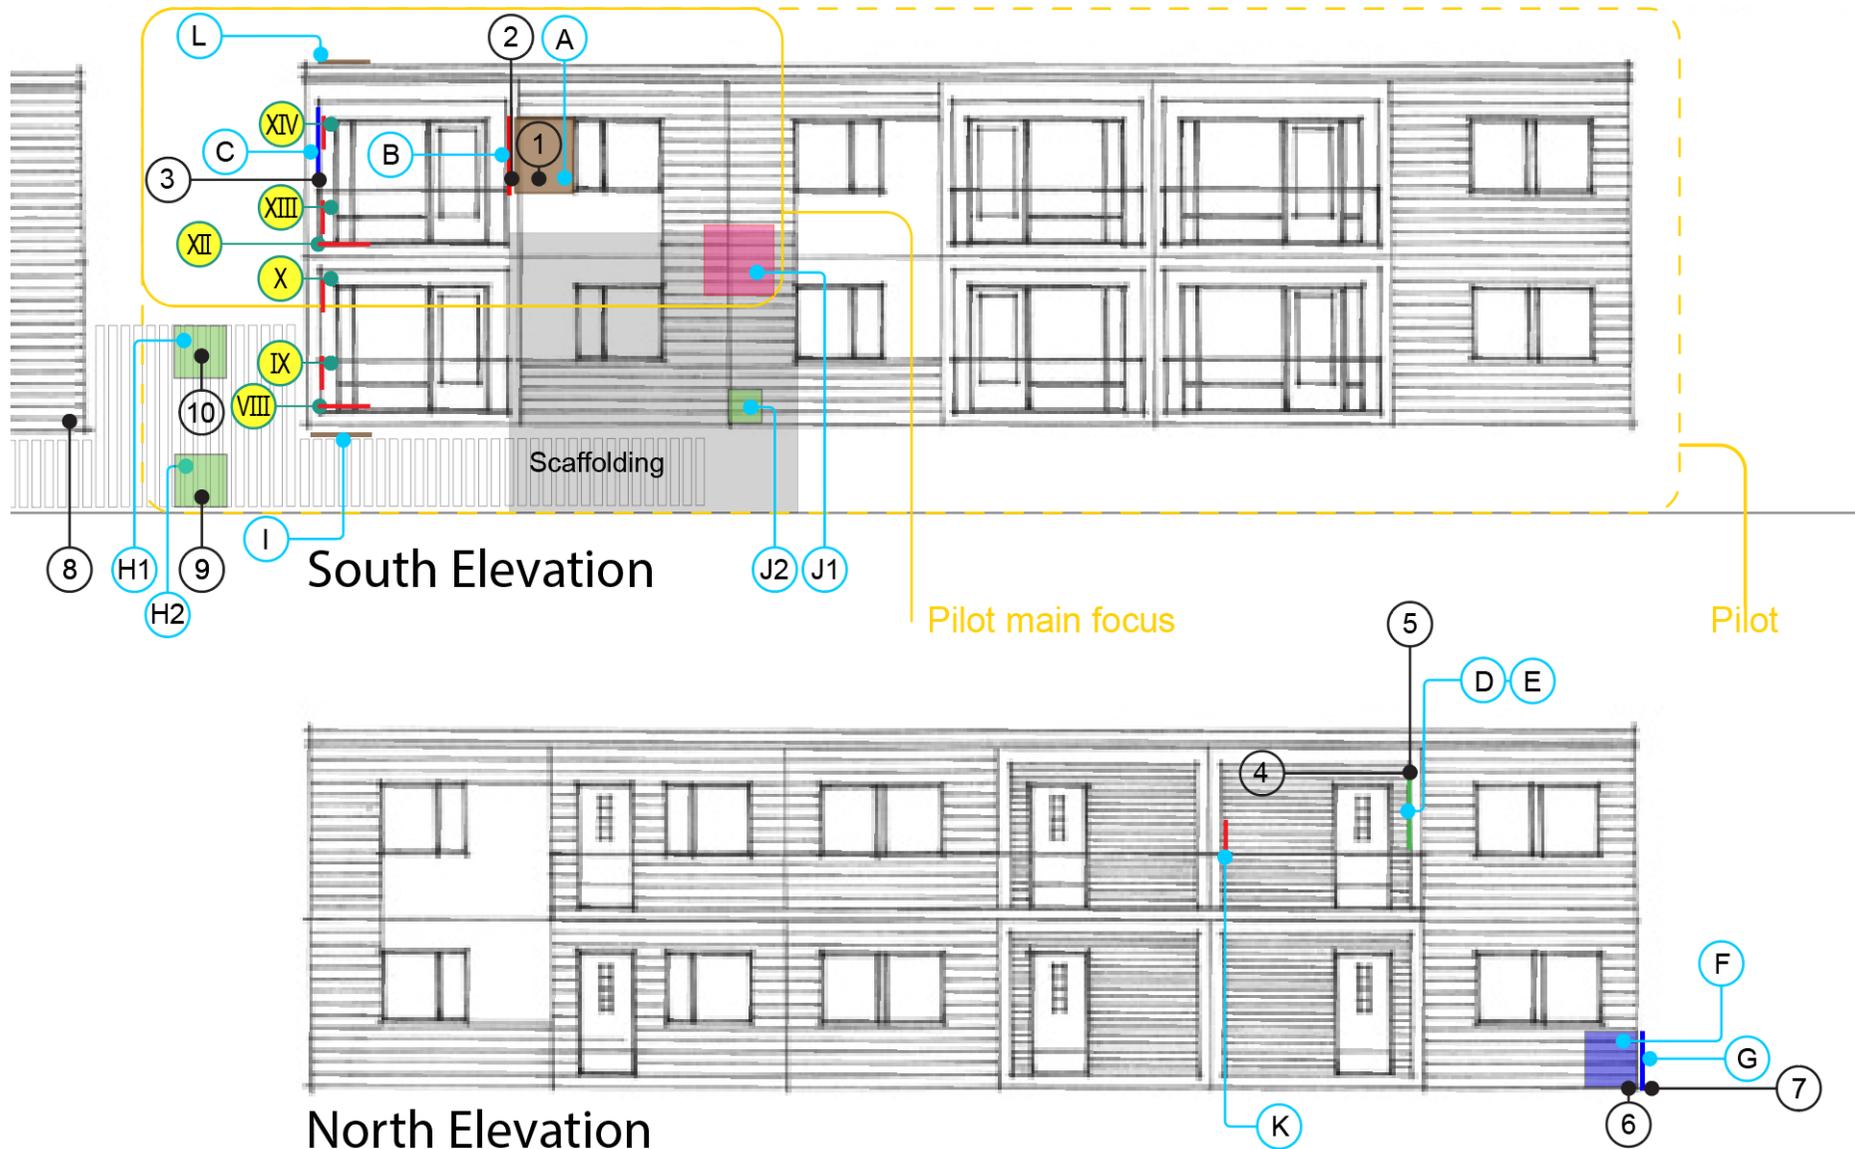
Figure 19. Elevation drawing of scanning positions

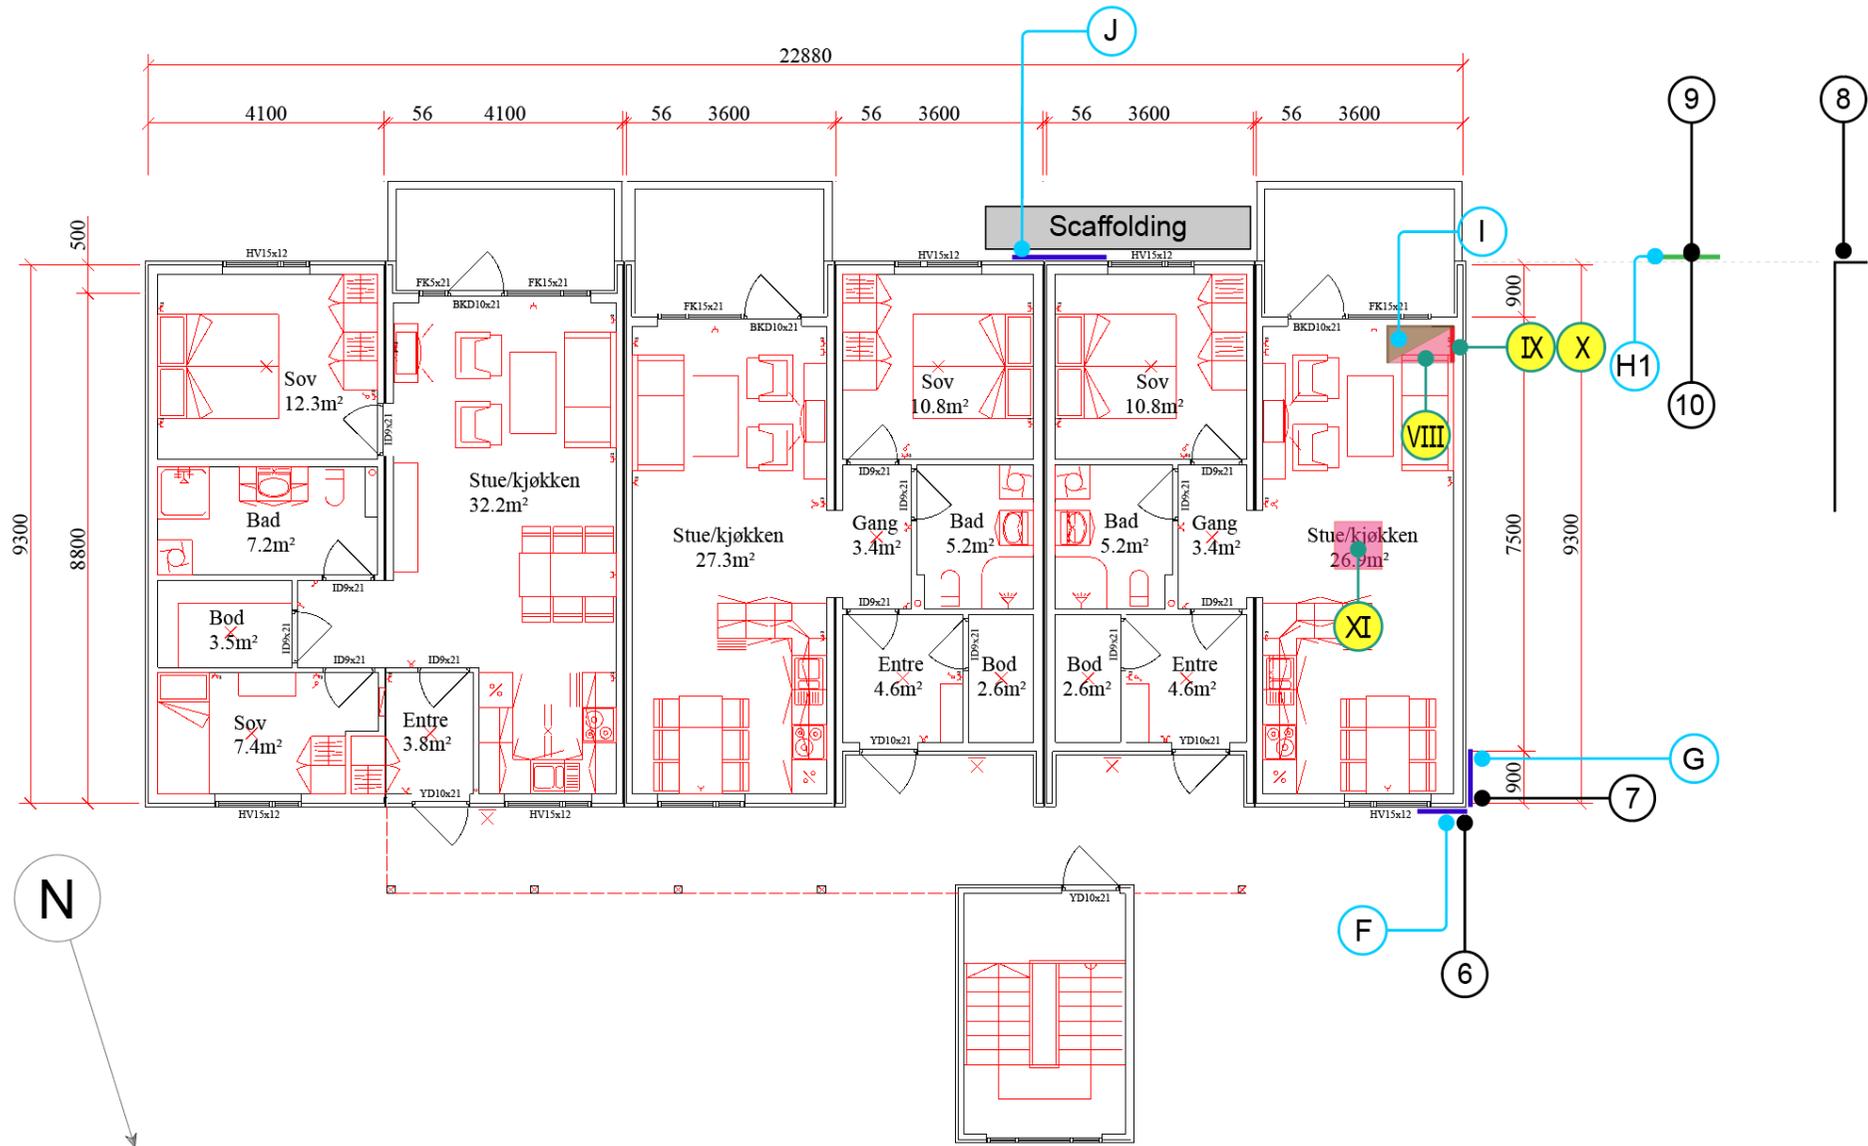
Figure 20. Plan drawing of scanning position ground floor (storey 1)

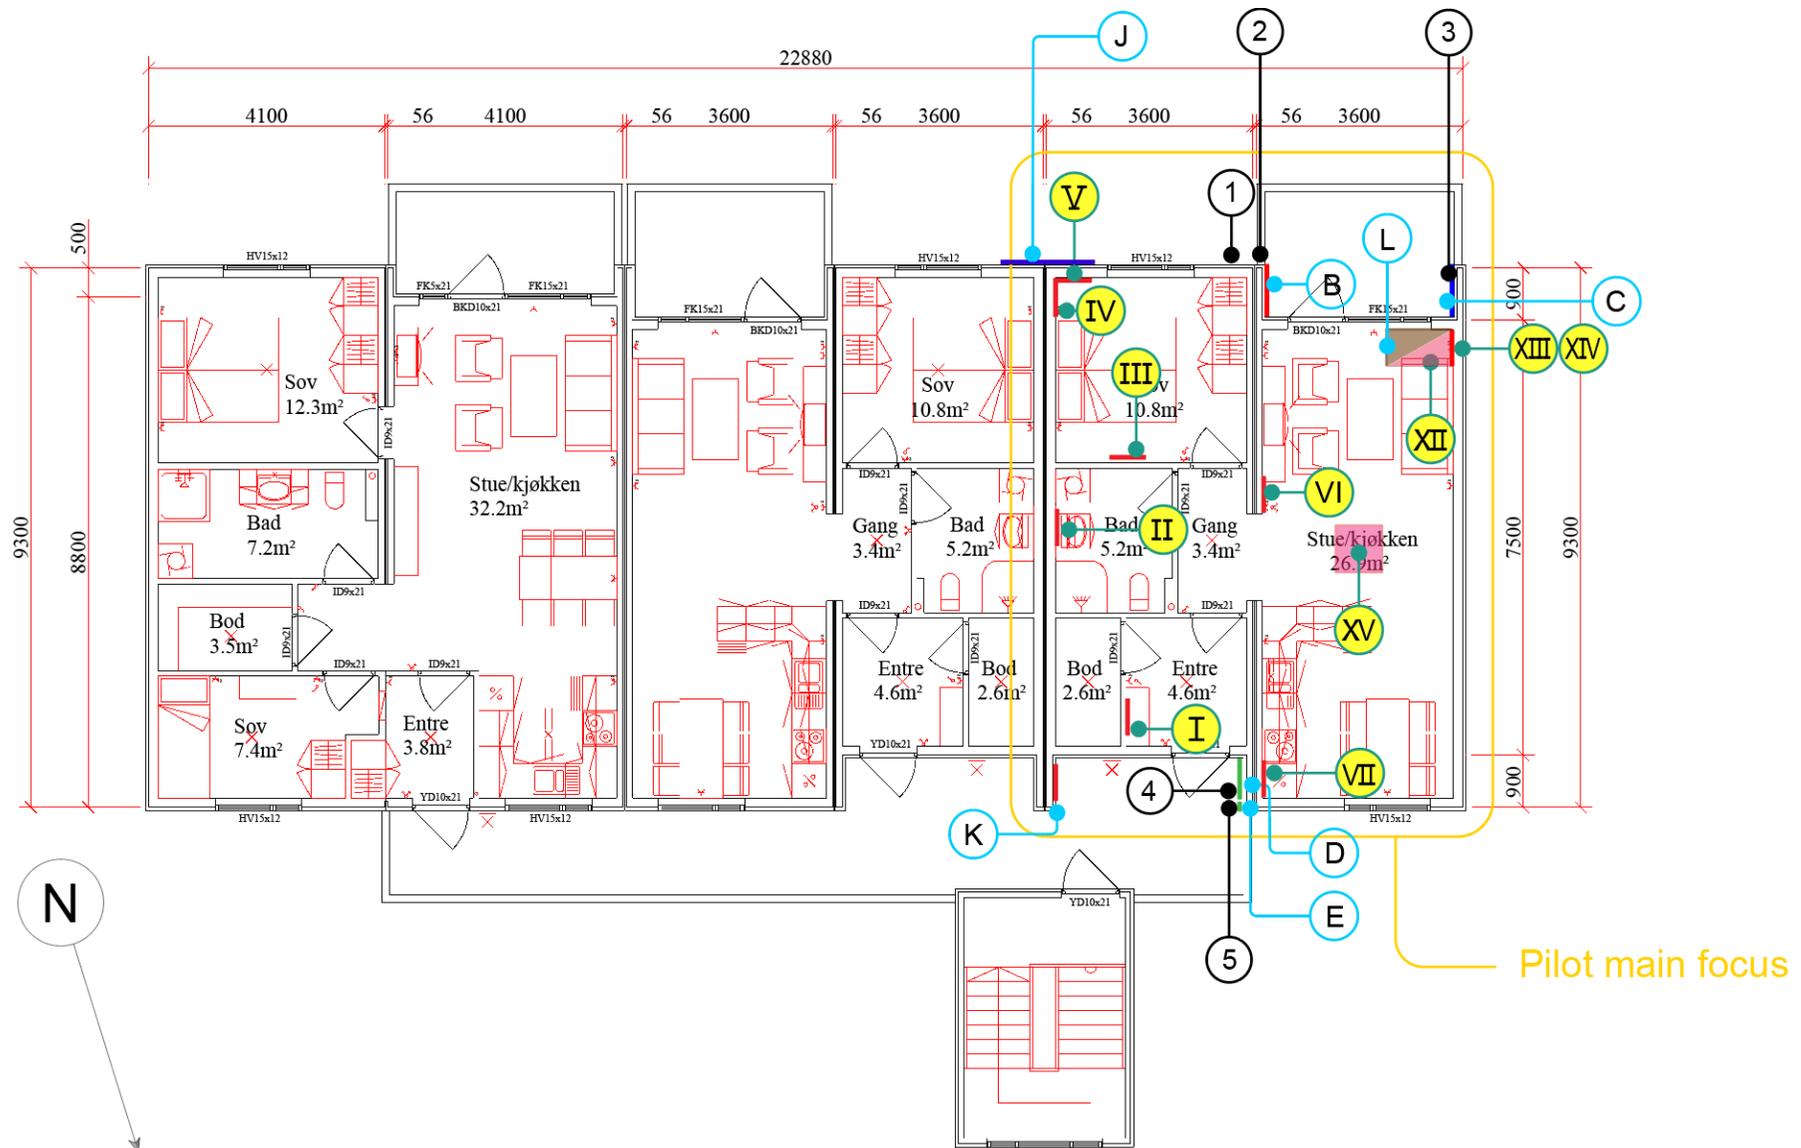
Figure 21. Plan drawing of scanning position upper floor (storey 2)

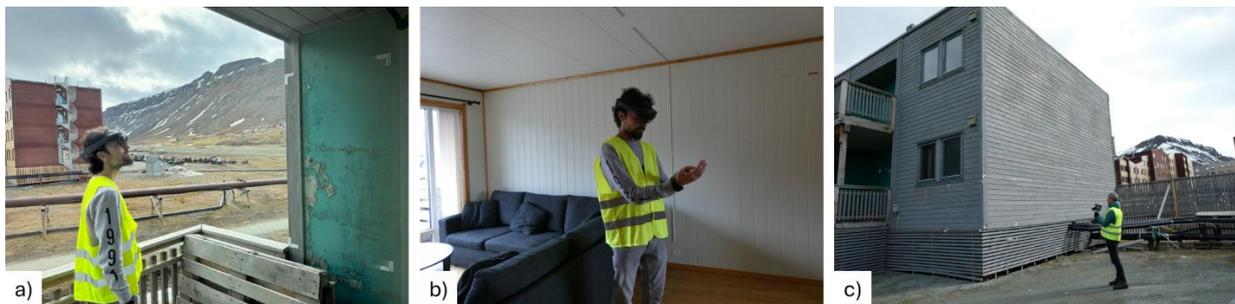
Data collection was carried out partially in parallel with both devices without interfering with each other, as they were used simultaneously in different spaces. Data was collected with HoloLens 2, marking structural elements, objects of interest for recycling, and the data collection areas of AHS and GPR devices. Data collection for the apartment on floor 2 began inside and ended outside, surrounding the building in a continuous scan, while the opposite trajectory was followed for the apartment on floor 1. Images of data collection are shown in Figure 22.

**Figure 22. Images of the data collection with Microsoft HoloLens 2 (a-b) and CHCNAV RS10 (c)**

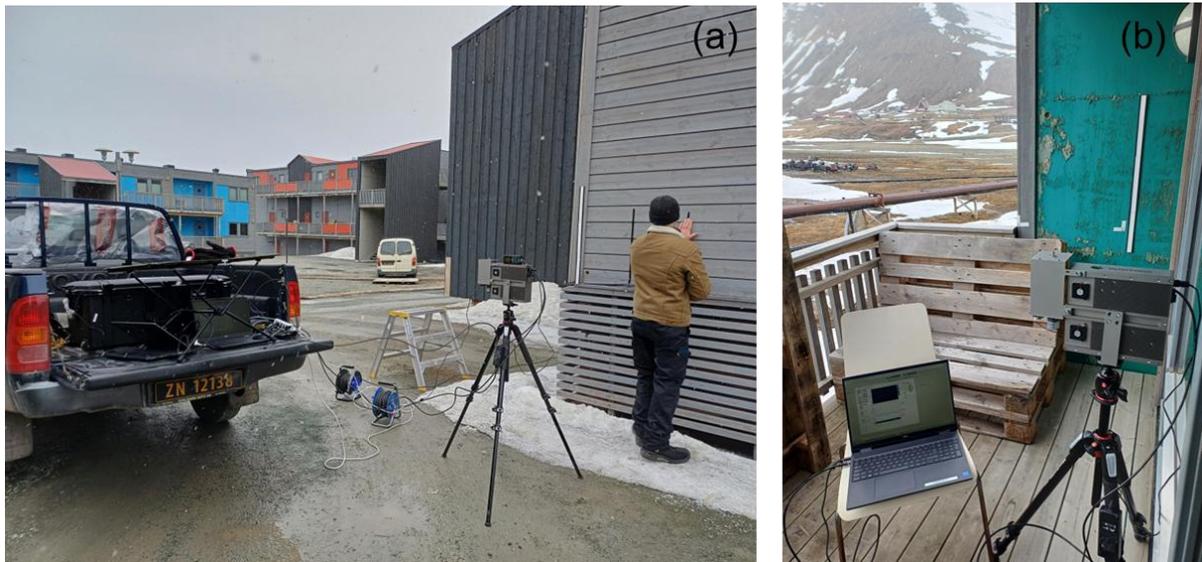
We collected data during the 28<sup>th</sup> and 29<sup>th</sup> of May, 2025. The selected areas for scanning were described in section 3.5.1.2. On the first day, there was snowfall and some scans had to be repeated. Overall, the quality of the data collected was sufficient for analysis. The AHS data collection was performed by Francisco Senna Vieira and Teemu Kääriäinen. Figure 23 shows how the AHS was setup on two locations of the pilot test.

**Figure 23. Setup of the AHS during the pilot test. (a) Preparation near area G and (b) setup during scan in area C.**

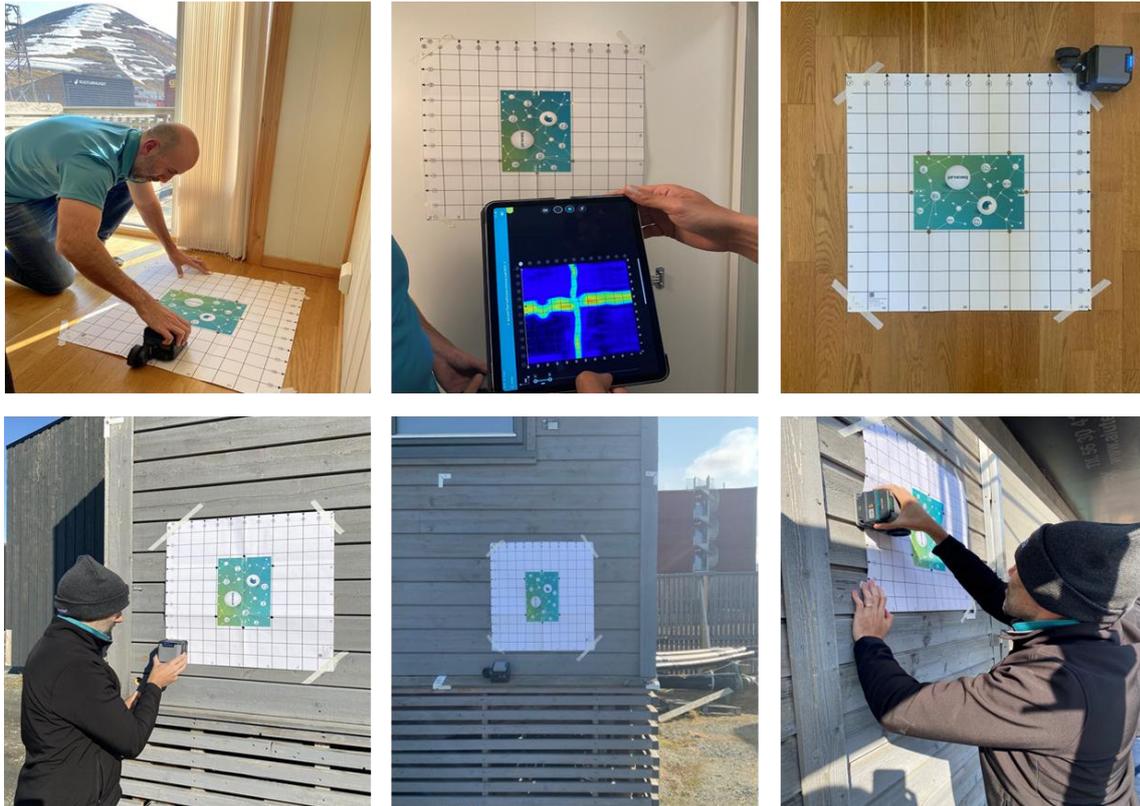
The scans were performed starting from the first-floor apartment internally, then moving to the second-floor apartment internally and finishing with the external scans. The device was controlled via the GP app and after the acquisition, the data were checked on-site to ensure there were no issues (or repeat scans if needed). Images of the data acquisition using GPR are presented in Figure 24.

**Figure 24. Photos from the GPR data collection from internal scans (top) and external scans (bottom).**

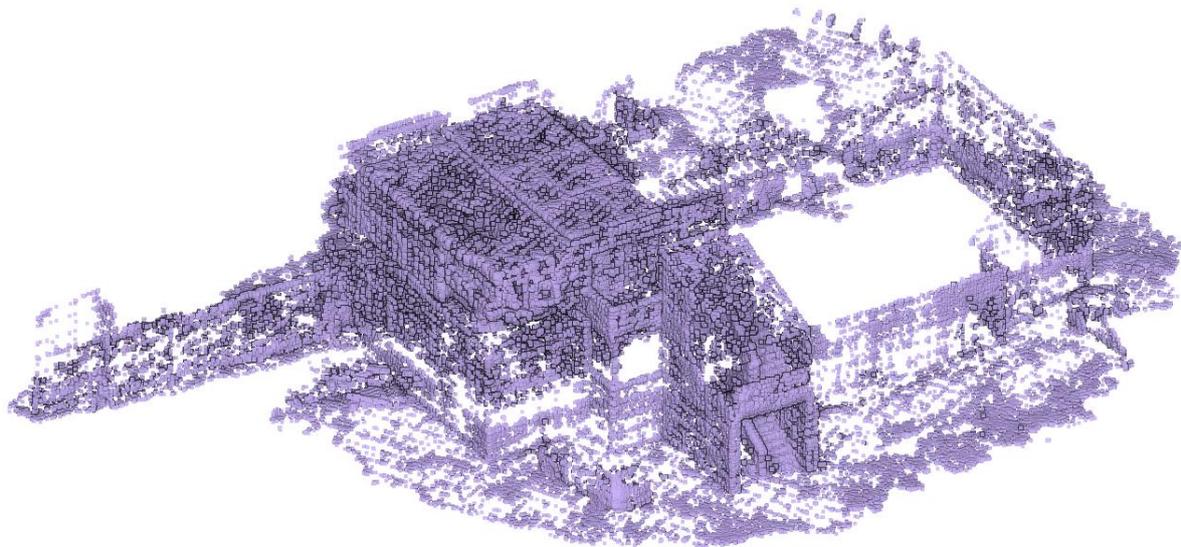
Device	HoloLens 2	RS10
Number of points	450 000	165 million

**Figure 25. Point cloud generated with HoloLens 2**

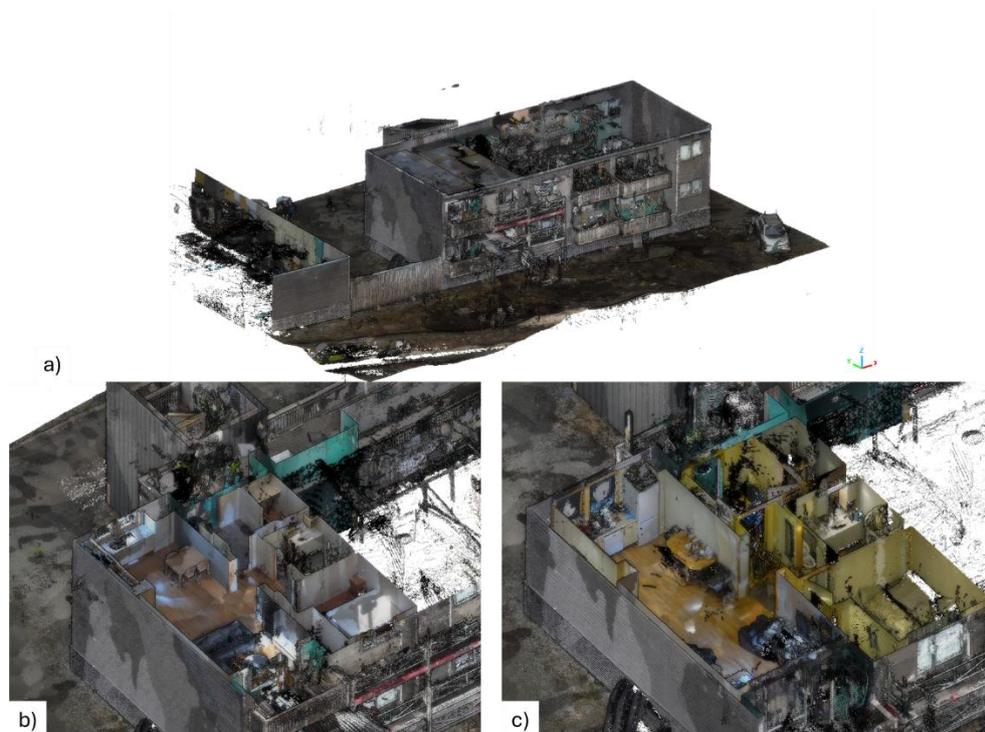
**Figure 26. Point cloud generated with RS10: a) outdoor, b) apartment floor 2, c) apartment floor 1**

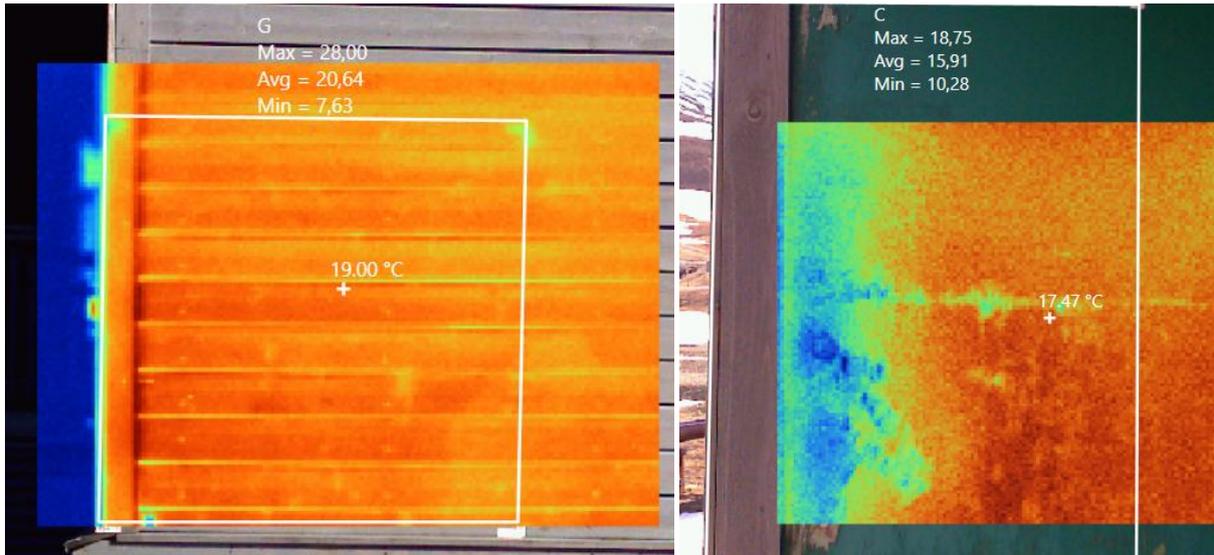
**Figure 27. Example thermal images of wood cladding (left, areas F, G, J) and particle board with damaged coating (right, areas C, D)**

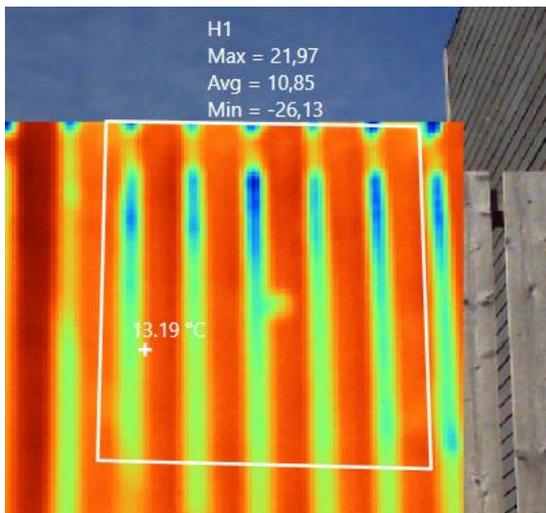
**Figure 28. Example thermal image of the wooden fence (areas H1 and H2)**

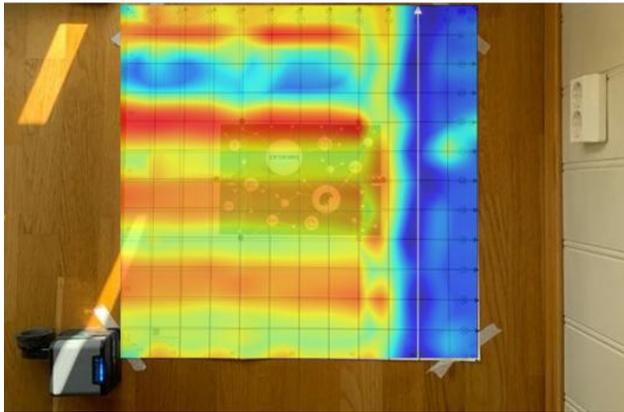
Position VIII

Figure 29. Depth slice from scan location VIII, where the heating elements can be observed

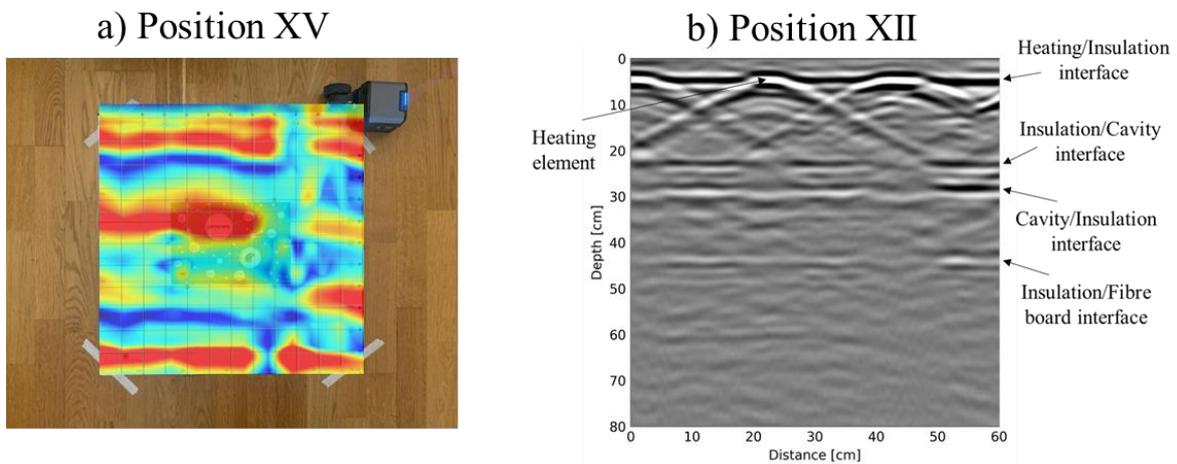
Similar results were obtained from the floor scans over the second floor, although as observed from the GPR data, the floor structure is slightly different. The underfloor heating structure is not as clear as in the first floor, which can be observed in Figure 30a), position XV. From the B-scan data in location XII (see Figure 30b), apart from the heating elements, four interfaces between different layers can be identified. The first one is the interface between the heating elements and the insulation layer observed around 5-6 cm depth. The next two flat responses correspond to the insulation/cavity and cavity/insulation interfaces, found at 21 cm and 30 cm, respectively, which mark the cavity that exists between the two insulation layers. Deeper in the floor, the interface between the insulation and fibre board is identified.

Figure 30. a) Depth slice at location XV that shows the underfloor heating and b) B-scan sample from floor scan XII in the second floor apartment.
