Creating materials banks  
from digital urban mining

# **D10.3: Strategic planning and data collection report 3**

As part of Work Area 6: Demonstrators in Existing Built Works, Task 10.3 in Work Package 10 has focused on establishing a baseline assessment for the Svalbard pilot site in Longyearbyen. The objective has been to develop a strategic plan for pilot implementation and testing, supported by the identification, analysis, and digitalization of the pilot building. This preparatory work provides the technical basis for subsequent pilot activities in Work Package 11 where analysis of the harvested data will be conducted.

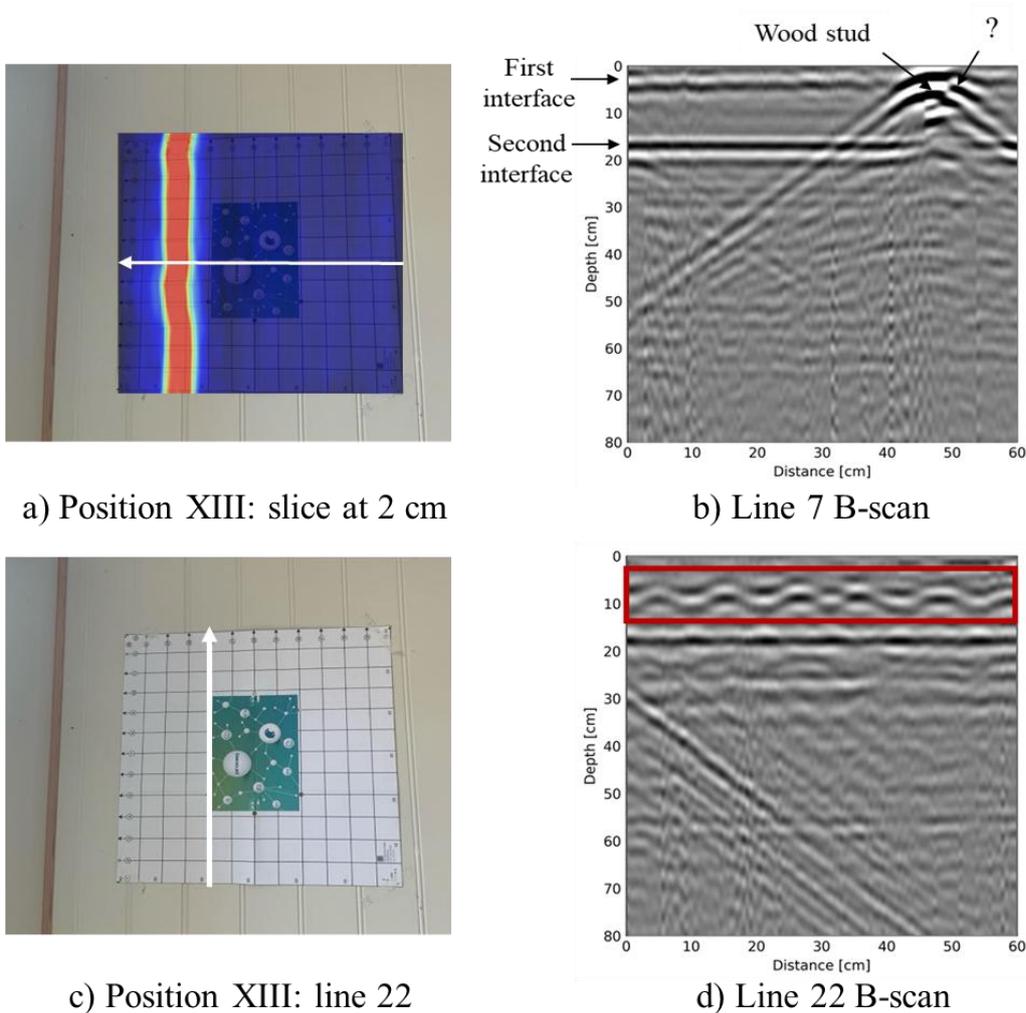
is presented here. Figure 31a) shows the location of the scan but also the depth slice at 2 cm overlaid where the vertical wooden stud can be seen. In all x-directed B-scans, another response can be seen very close to the stud, as displayed in line 7 in Figure 31b), which remains unidentified. In some of the measurements, two interfaces can be identified as shown in Figure 31b) with the first one possibly corresponding to the fibre board/insulation interface and the second one from the backwall.

**Figure 31. a) Depth slice at wall location XIII showing the vertical wooden stud identified, b) Line 7 B-scan at location XIII, c) Location of line 22 in position XIII and d) Line 22 B-scan.**

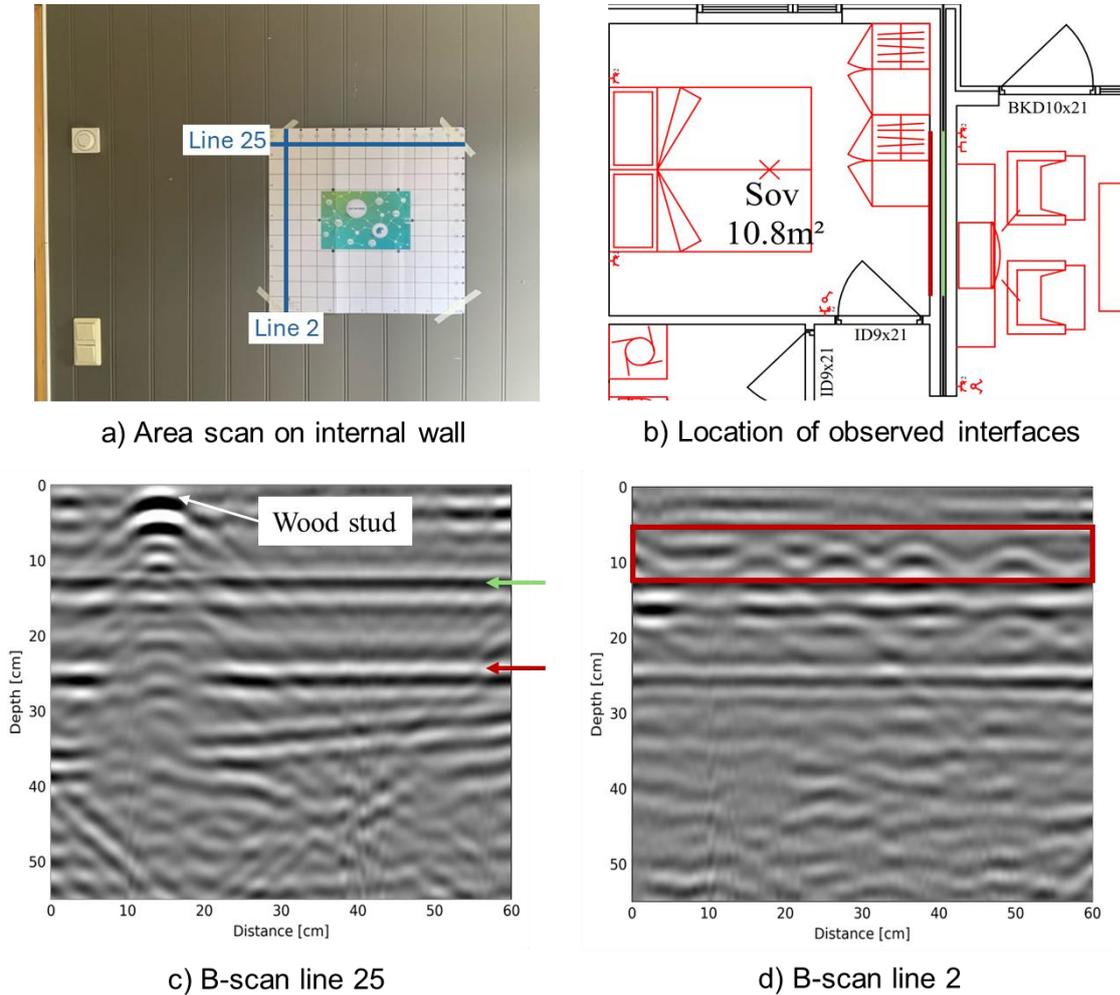
The pattern of hyperbolas is also visible in the scans of this wall at ~6 cm depth, as shown by the Line 2 B-scan in Figure 32d). Since this is a repeated pattern occurring at different scan locations, it is highly likely to be structural elements inside the insulation layer.

**Figure 32. Results from area scan on internal wall between living room and bedroom of second floor apartment.**

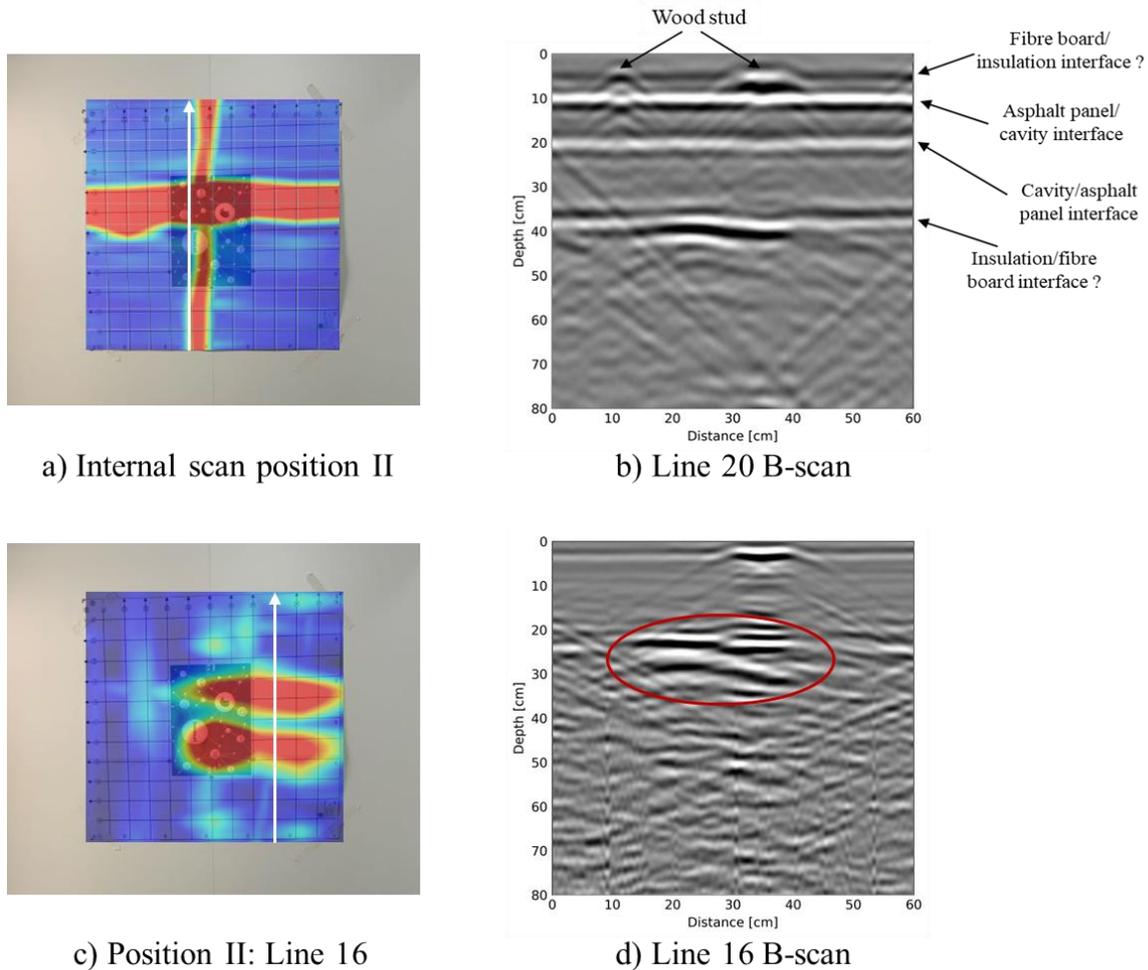
Furthermore, different interfaces between the different layers in the wall were found, namely, the fibre board/insulation, insulation/cavity and cavity/insulation interfaces as seen in Figure 33b). The latter one is from the wall mirroring in the other apartment. The interfaces are present only in some of the B-scan data

**Figure 33. Internal scans on bathroom wall between the two apartments of the second floor**

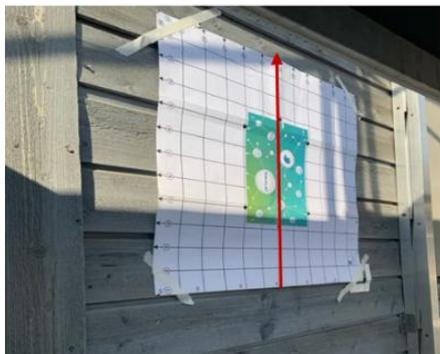
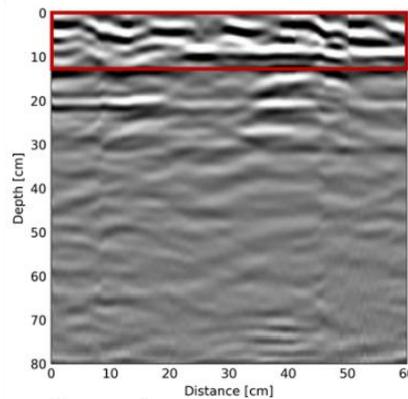
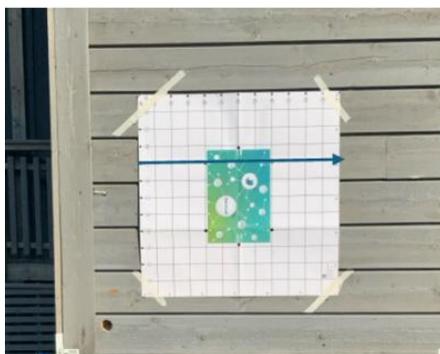
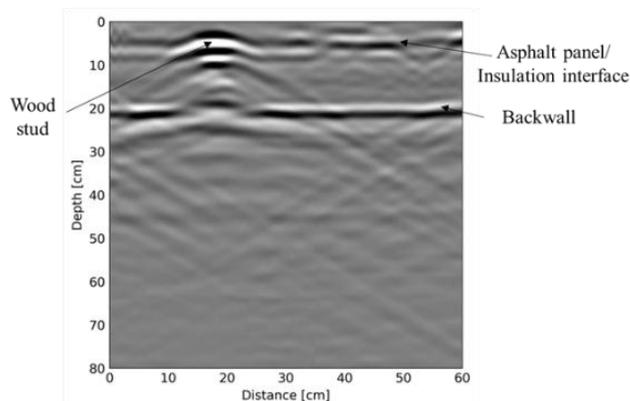
a) External position J1: y-directed scan

b) External position G: x-directed scan

**Figure 34. a) Y-directed B-scan at external position J1 illustrating the clutter caused by the cladding and b) X-directed scan at external position G showing other responses observed.**

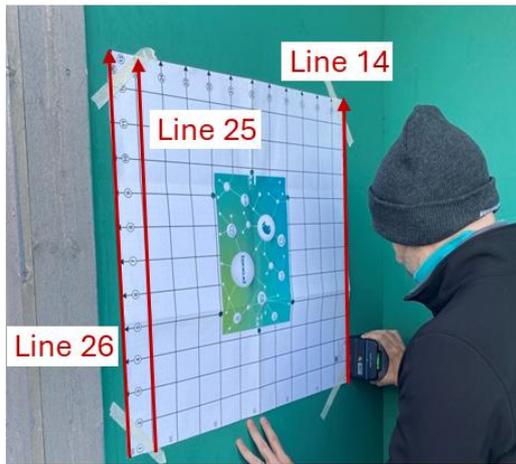
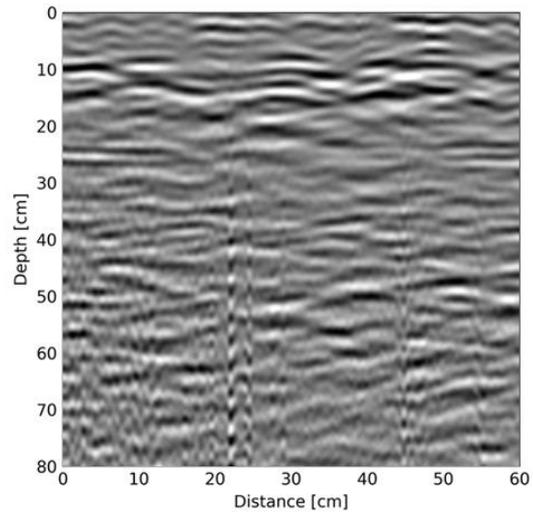
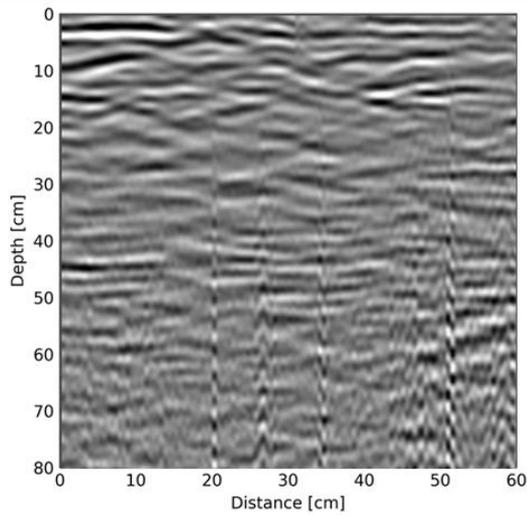
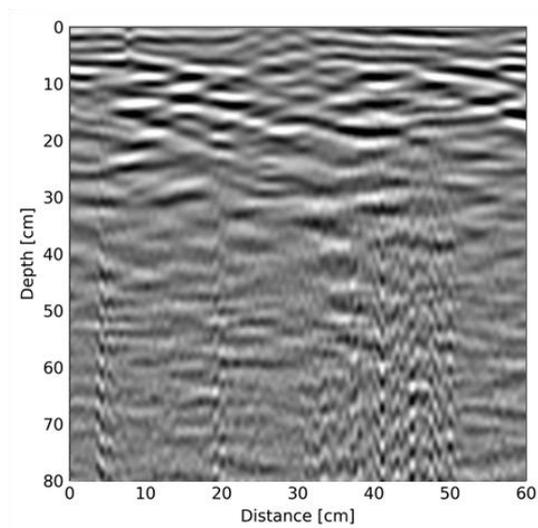
Walls external to the flat where no cladding was present were also scanned. These were a wall next to the main door (position K) and two walls in the balcony area of the second-floor apartment (positions B and C). Similar structure with studs and insulation was observed also in these areas, however there was significant clutter in the data which can be attributed to high moisture content and/or voids. Some examples can be seen in Figure 35 for position K where three B-scans are presented from lines 14, 25 and 26 which illustrate the variations observed in the data. Therefore, it is concluded from the data that this area has a high likelihood of deterioration.

a) External scan position K

b) Line 14 B-scan

c) Line 25 B-scan

d) Line 26 B-scan

**Figure 35. External wall scan position K and B-scan examples showing the variations observed in the GPR data in this wall area.**
